Glenfield Footpath Bridges – 9 Year Performance Review

In 2017, three pedestrian Bison bridges and a boardwalk were installed on the public footpath linking Blackthorn Road in Glenfield. The route passes through a wooded corridor with a small watercourse, providing a popular walking route for local residents and dog walkers.

Nine years later, we returned to site to see how the bridges have performed in real-world conditions.

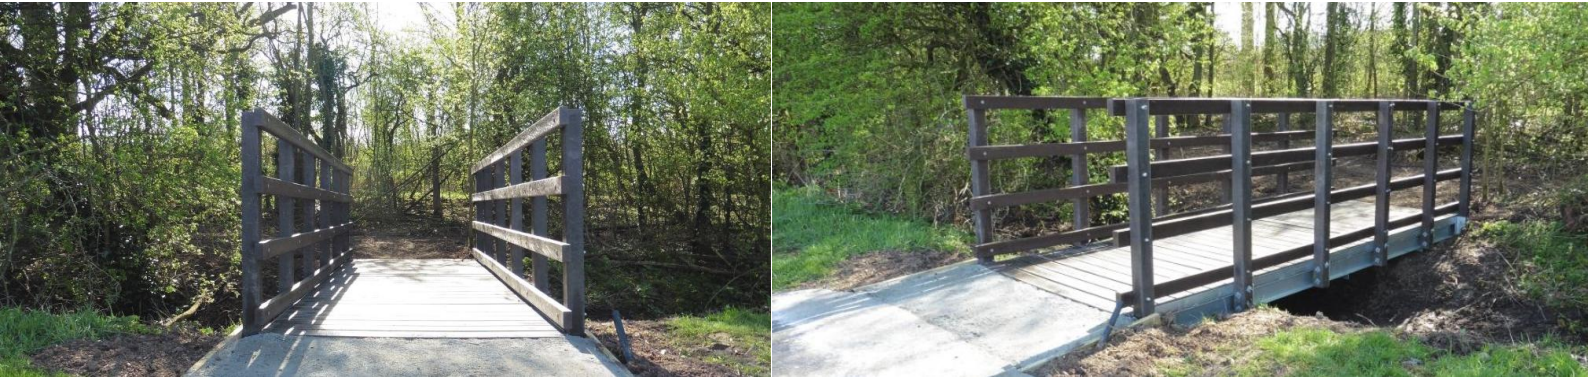
Bison bridge images, installed 2017

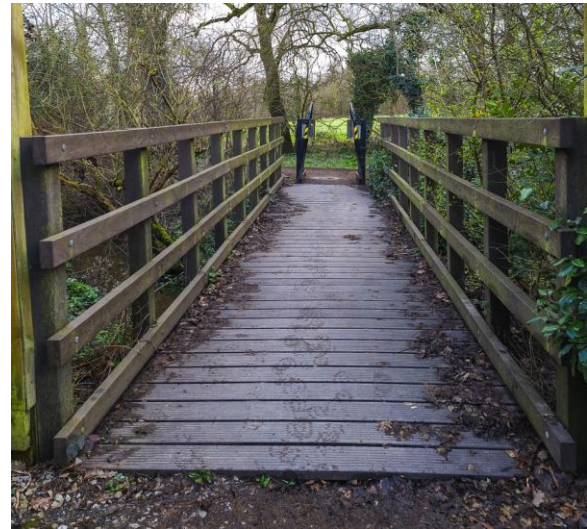
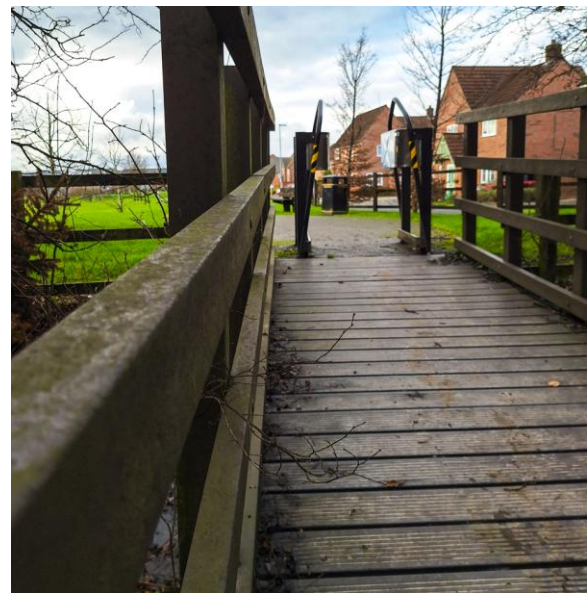
Structurally the bridges remain in very good condition.

The deck remains level with no visible sagging, twisting or distortion of the structural members.

A common concern with recycled plastic products is that they may creep or warp over time, particularly when exposed to temperature changes. After nine years in service, there is no evidence of movement or deformation in either the structure or deck boards.

Despite being exposed to outdoor conditions for nearly a decade, the deck boards show very little colour change or UV degradation.

There is no surface cracking, chalking or bleaching visible, indicating strong long-term UV stability.

As expected in a woodland setting there is some lichen and organic growth on parts of the structure.

Importantly the growth is superficial only and does not affect the structural integrity or performance of the material.

To check for wear, a new Re-Life deck board was placed directly on top of the existing bridge deck for comparison.

The ribbed anti-slip profile on the original deck boards remains clearly defined and is almost identical to the new board. There is no visible rounding or smoothing of the ribs, which is often the first sign of wear on traditional bridge decking.

After nearly ten years of pedestrian traffic, the deck shows minimal measurable wear. The hardened moulded surface has retained both its shape and slip-resistant properties.

Aside from natural biological growth typical of woodland environments, the bridges appear largely unchanged from when they were first installed.

Bison bridge images, 2026
